### SB - Service Bulletin ASB - Alert Service Bulletin RAS - Repair Approval Sheet

Doc. No.
SHARK\_SB\_004

Inspection and modification of oil hose attachment.

All SHARK types and models.

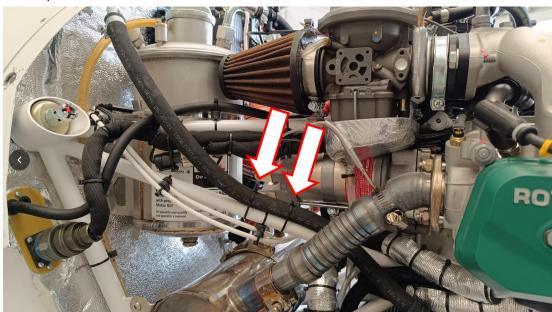
The purpose of this service bulletin is to address a potential safety issue concerning the current attachment of the oil hose (see figure below) using two plastic zip ties. The deterioration of these zip ties can result in failure, allowing the oil hose to come into contact with the exhaust tube. This could potentially cause an oil leak, posing a safety hazard.

The oil hose is currently secured with two plastic zip ties. If the zip ties fail, the unsecured oil hose could shift and contact the nearby exhaust tube, potentially leading to a rupture or leak due to high temperatures.

To mitigate this risk, the hose will be repositioned so it leads behind the middle engine mount tube.

- Inspect the oil hose attachment in the engine compartment, verify the condition of the plastic zip ties.
- If any zip ties are found to be deteriorating, frayed, or broken, replace them with new plastic zip ties as a temporary fix.
- Ensure the oil hose is not in contact with the exhaust tube.
- If contact is observed, do not operate the aircraft until the issue is resolved.

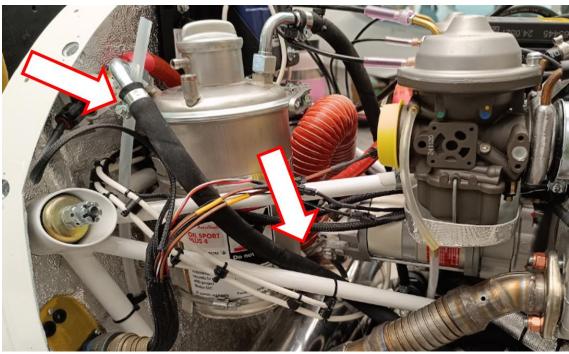
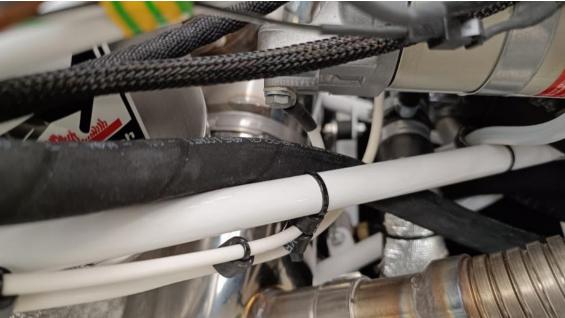
- Remove the existing plastic zip ties.
- Disconnect the hose from the oil tank by loosening the screw on the hose clamp and pulling off the metal tube.
- Seal the hose with a suitable plug or cap to prevent oil from spilling.
- Route the hose behind the middle engine mount tube as shown in the next figure:

- Secure the oil hose using 2 zip ties to the middle engine mount tube, ensuring that the zip ties do not compress the hose.
- Verify that the oil hose is securely fastened and positioned away from the exhaust tube or any sharp edges.

After installation, ensure the zip ties are tightly secured.

• Confirm the oil hose is in a safe position, with no risk of contact with the exhaust tube or sharp edges.
